## Electrical Engineering Department

Investigation of Cold Cathodes  
for  
Long Life CO<sub>2</sub> Waveguide Lasers

Final Report  
for Contract F49620-79-C-0076

U. Hochuli

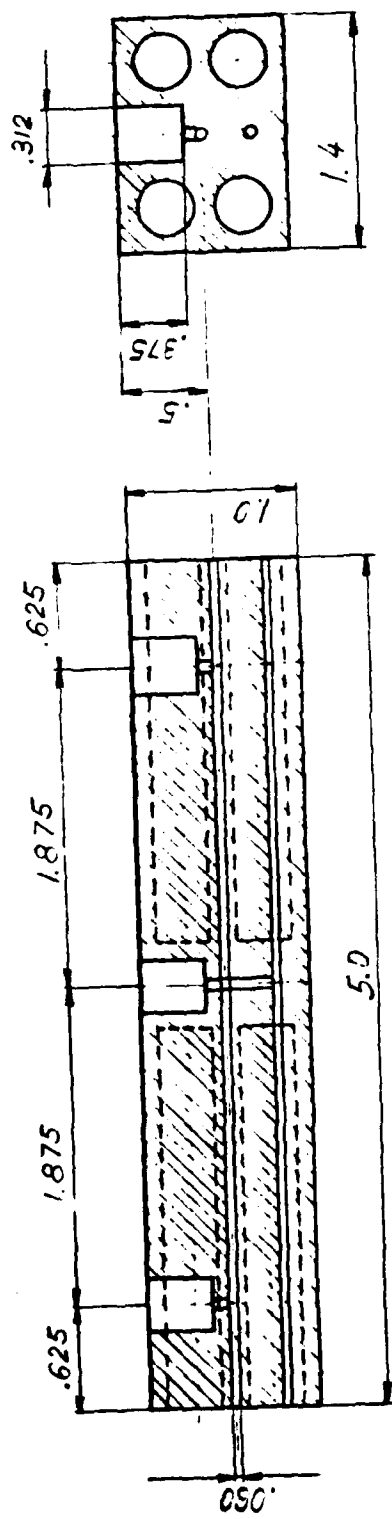
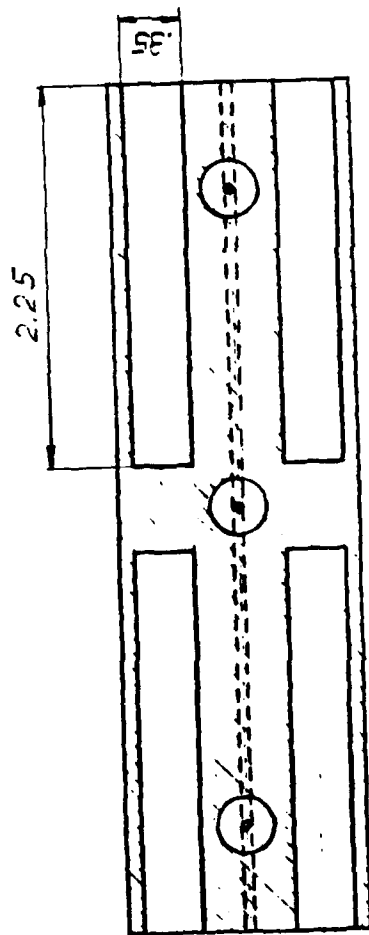
Fig. 1

Careful observations on the more than 50 different cathodes being tested indicate that semiconducting, sintered NiO is one of the better cathode materials. Such cathodes were actually used to generate the life test data with two of the BeO laser structures shown in Figure 1. Both of these lasers used three cathode type electrodes, one located 5/8" from each bore end and one near the bore center. Laser No 1 used both end electrodes as 2mA cathodes and the center electrode as the common 4mA anode. Laser No 2 worked with the end electrodes as 2mA anodes and used the center electrode as a common 4mA cathode. From the discharge tube results we know that the 4mA cathode is prone to considerably heavier sputtering than the 2mA cathode. Both lasers had indium "O" ring and indium film seals developed by us 11 years ago. All the seals on Laser No 1 were perfect but Laser No 2 had

LASER STRUCTURE  
(BeO)

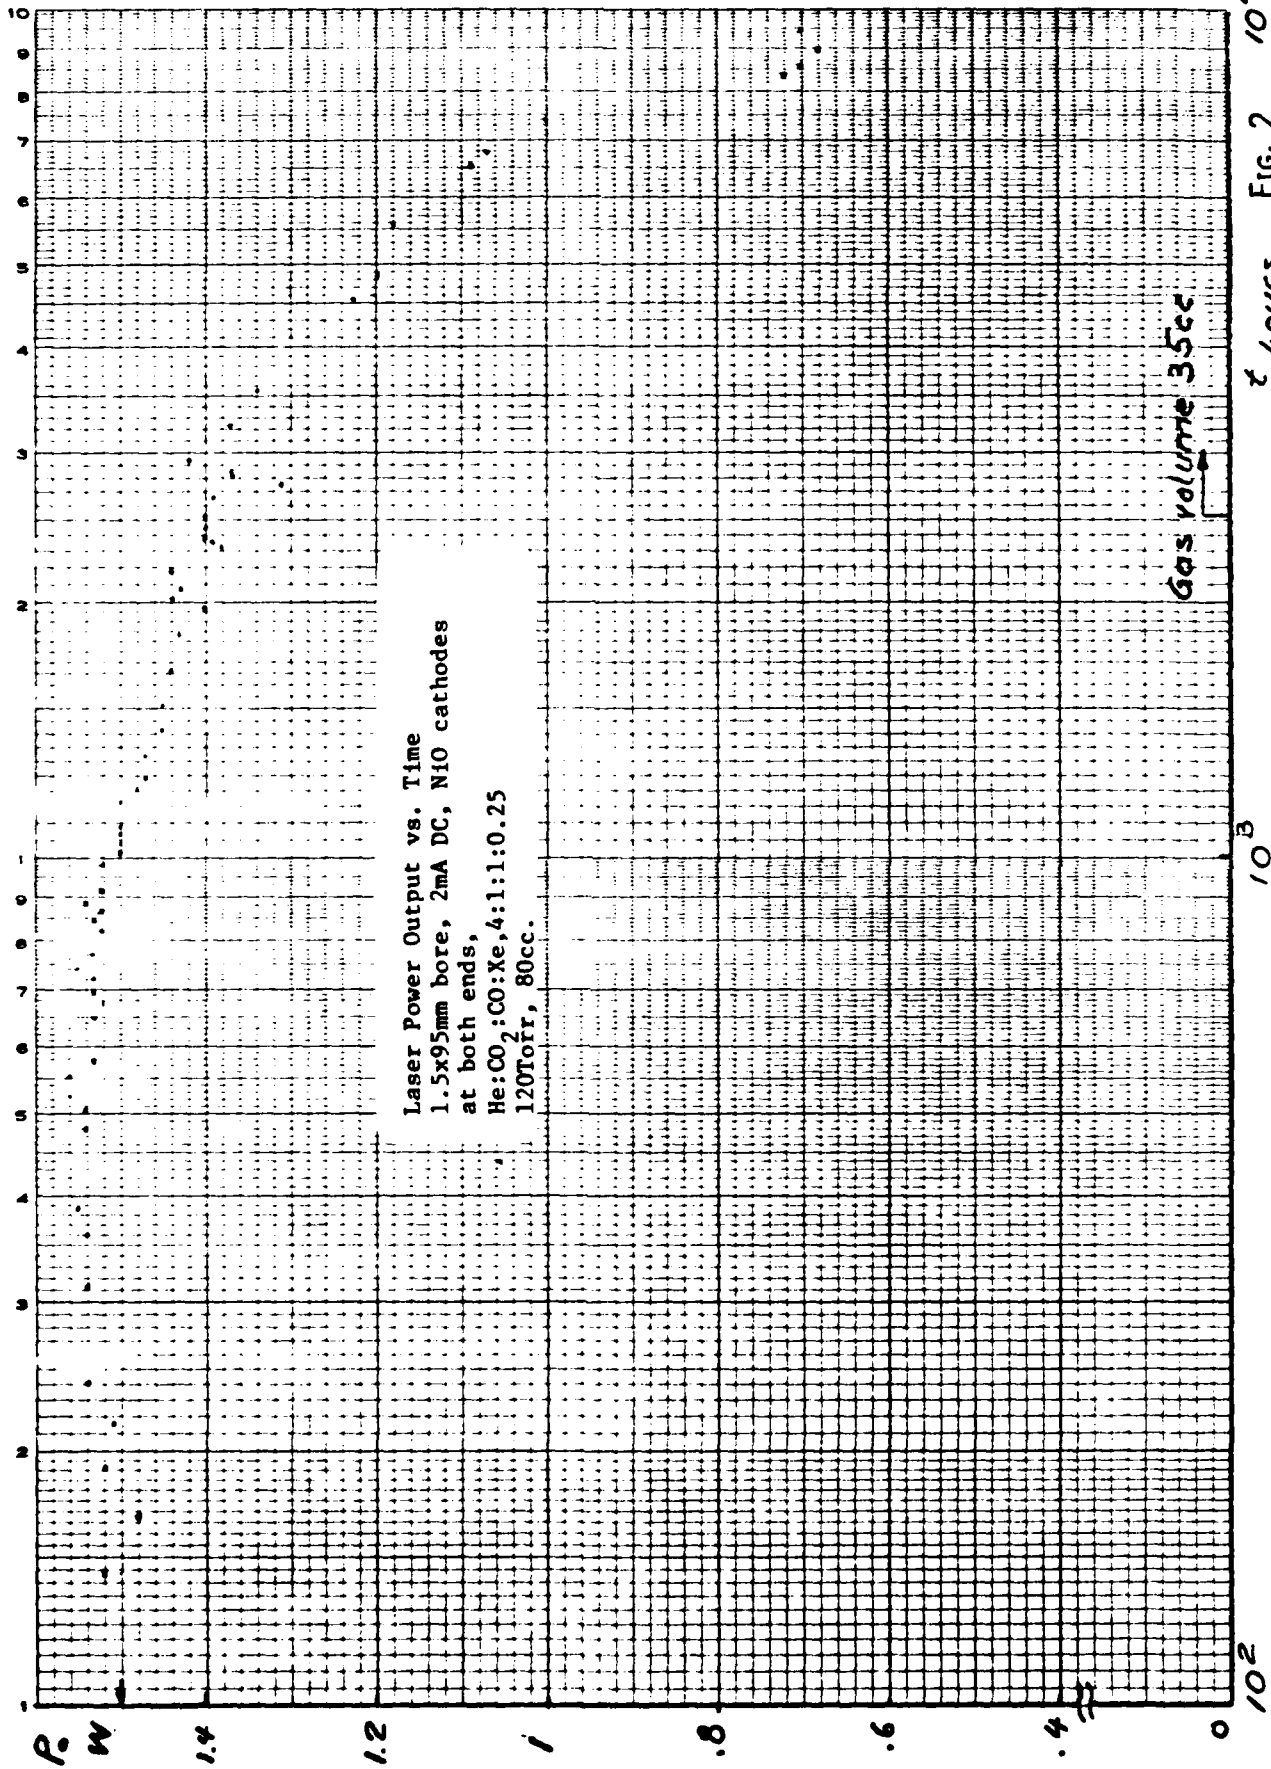
FIG. 2 10<sup>4</sup>

As Figure 2 shows the power output of this laser decreased from 1.54W to 0.7W after 9500 hours. Evacuation to 1 Torr and refilling restored the power to only 0.86W. Vacuum pumping and 100°C heating for two days, followed by refilling, restored the output power to 0.9W. Our laser structures use external windows (uncoated ZnSe, tilted 7° to avoid retroreflections) as vacuum seals behind the internal mirrors. Power supply failure over one weekend lowered the laser body temperature to the 15°C cooling water temperature.

Humidity had condensed on these windows and together with the dust and the grime formed water spots. A cotton swab and alcohol treatment could not remove these spots. At the time we thought that this visual degradation would not absorb much power at  $10.6\mu$ . Repolishing these windows, on the laser, with Linde type A and B  $Al_2O_3$  polishing compound improved the laser power output to 1.34W. Replacement of two additional mirrors (front surface Al coated, used for deflection of power from both laser ends onto power meter) further increased the power meter reading to 1.4W. This value is within 10% of the original 1.54W and is an indication that no serious mirror damage had occurred. Removal of the laser mirrors revealed the central 1.5mm area either by breathing on it or by noticing a very faint greenish hue through observation of the surface at a glancing angle. Very few specks of black NiO with diameters of 10 to 30 microns could be seen in the BeO cathode cavities. The  $Al_2O_3$  sputter shields also had a light black color in the central hole and the color gradually thinned out into a very light greenish hue over most of its front surface. This greenish hue did not seem to extend into the cathode cavity of the BeO body.

Auger spectroscopic analysis, performed by the National Security Agency, showed about equal peaks of Ni and C plus an excess of O for the cathode sputtershield deposits and a carbon layer on the mirror spots. One mirror spot had a  $50A^\circ$  thick carbon layer while the other mirror spot had a much thinner layer which may have been the result of  $CO_2$  adsorption.

No trace of chlorine was found on either mirror. These results are strange because for a laser which is symmetrical with respect to both mirrors we expect similar results for both mirrors. Optically we did indeed see similar spots of faint discoloration for both mirrors. We believe that the heavier, or even both carbon deposits resulted during the gas refilling operation that took place after 9500 hours. We refilled the laser slowly but even then we may have stirred up carbon deposits in the bore and swept them to the mirrors. Since the gas inlet port was asymmetrically located behind one of the cathodes it could explain the different thicknesses of the mirror deposits. Later, this carbon dust may have absorbed enough laser power to bake on to the mirror surface. So far we do not think that we have a good explanation for the optically visible mirror spots and we may have to analyze these areas again. It may also turn out that Auger surface analysis can not explain these discolorations which may be the result of UV exposure. We have in the past observed permanent color changes of dielectrically coated ZnSe mirrors as a result of simple heating to perhaps 200 to 300°C in air.

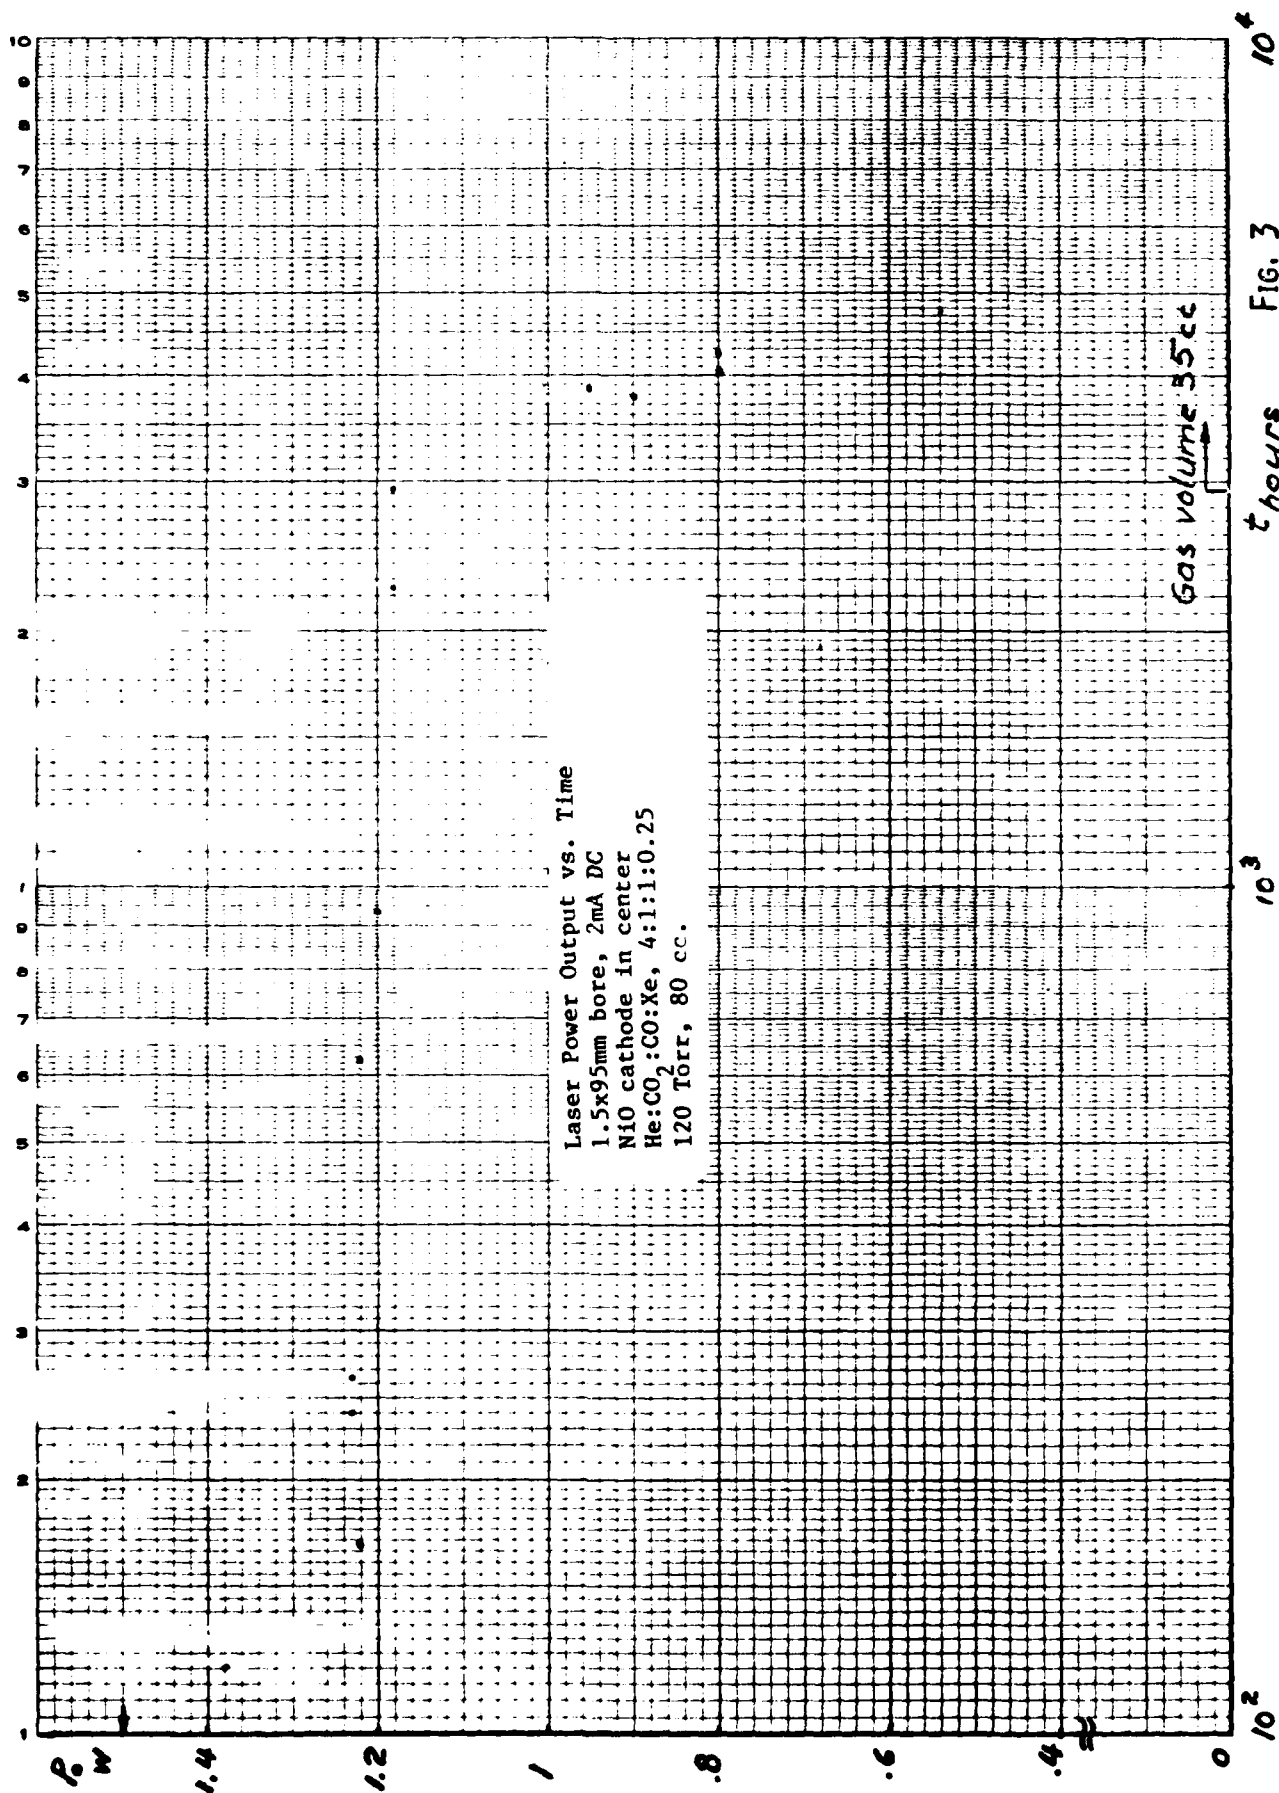
FIG. 3

Figure 3 indicates a power drop from an initial 1.5W to 0.54W after 4750 hours. Increasing the gas volume again to 80cc, by reconnecting the laser to the same gas supply

that was used for the first 2900 hours, raised the output power to 1.2W. Pumping down to 1 Torr and refilling the laser with new gas increased its power output to 1.4W compared to 1.5W for the new laser. This indicates that no serious mirror damage had occurred. The laser was then carefully evacuated with the Vac-Ion pump and outgassed for two days at 100°C. Refilling and measuring the power output gave 1.39W or essentially the same as before. 1300 hours later this output was down to 0.68W, almost as before. Leak testing revealed a small leak through the once repaired crack in the BeO structure. This leak was most likely caused by the previous 100°C heating cycle.

Opening the structure revealed a crater like, metallic looking, material build-up around the center hole in the cathode sputter shield. This deposit turned out to be Ni originating from the sputtered, reduced NiO of the cathode. The cathode cavity in the BeO body contained about 20 flakes in sizes ranging from 10 to 50 microns in diameter. About half of them appeared metallic and were magnetic and the rest looked like black NiO. X-ray fluorescence analysis confirmed Ni as the dominant composition of the flakes.

Inspection of the mirrors under a microscope revealed no surface degradation. Breathing on the mirrors enabled us to distinguish the central area opposite to the 1.5mm bore. X-ray fluorescence analysis also distinguished this area but did not reveal a different composition from the rest of the

mirror. Auger spectroscopy, performed at the Naval Research Laboratory, showed an excess of chlorine and oxygen in the central mirror area. The excess oxygen most likely resulted from either the pure oxygen discharge used to clean the laser before the actual filling took place or from the exposure to the laser discharge that always contains oxygen from dissociated  $\text{CO}_2$ . However, the presence of chlorine is more difficult to explain. One possible chlorine source may be the indium "O" rings. These "O" rings were cleaned in 50% HCl followed by ultrasonic cleaning in distilled  $\text{H}_2\text{O}$  and alcohol. Any formation of  $\text{InCl}$ ,  $\text{InCl}_2$  and  $\text{InCl}_3$  should easily be dissolved in  $\text{H}_2\text{O}$  and washed away. Other chlorine sources may be: the 0.0005% Cl present in the nickelous nitrate used as the basis material for our NiO cathodes and/or chlorine presence in the 5% binder used in the  $\text{Al}_2\text{O}_3$  sputtershield ceramic.
